***Fire Door Inspection Report***  
***Prepared by Triman Passive Fire***  
***For Test Client***

**123 Old Kent Road, London, SW1 2AA**

Surveyed: **17th September 2020** by **Rod Gilson**

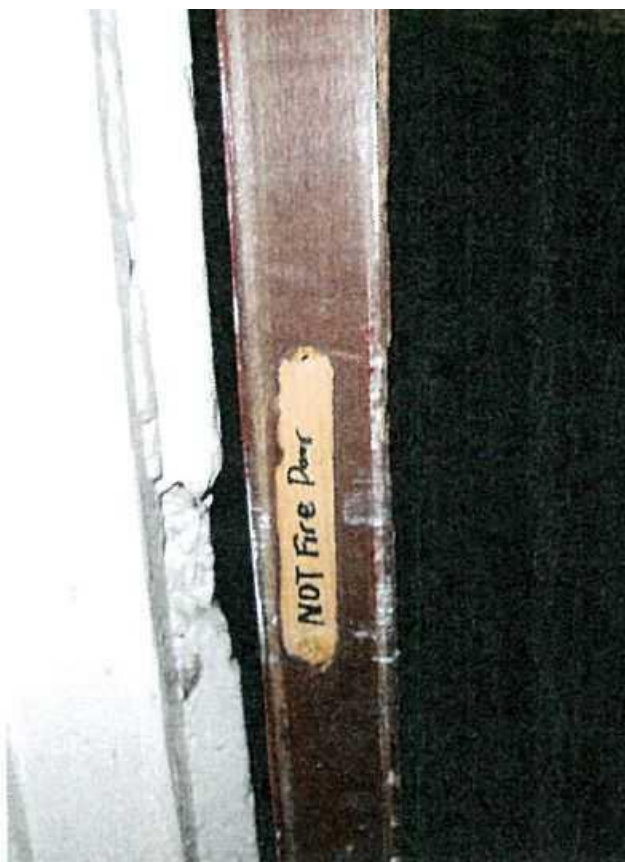
[Photo 1](#)

Door leaf has certification or manufacturers label attached.	No	* Client to provide proof of certification. <b>Essential</b>

Asset	Priority	Item	Response	Recommended Action	Photo
FRD001	Urgent	Closers appear in (GC) without oil leakage.	No	* Arrange for installation of a door closer that is rated to BS1154 power level 3. <b>Urgent</b>	  <a href="#">(Photo 5)</a>
FRD001	Urgent	Fitted all round & in (GC).	No	* Arrange for installation of intumescent seals.	  <a href="#">(Photo 4)</a>
FRD001	Urgent	Latch engages without excessive movement when shut.	No <i>Lock mechanism incomplete, new lock required.</i>	* Arrange for installation of a new latch.	  <a href="#">(Photo 3)</a>
FRD121	Essential	Warning signage present.	No	* Arrange for installation of the correct fire door signage.	No photo taken
FRD121	Essential	Door signage both side of door leaf.	No	* Arrange for installation of the correct fire door signage.	No photo taken
FRD121	Essential	Door leaf has certification or manufacturers label attached.	No	* Client to provide proof of certification.	  <a href="#">(Photo 1)</a>

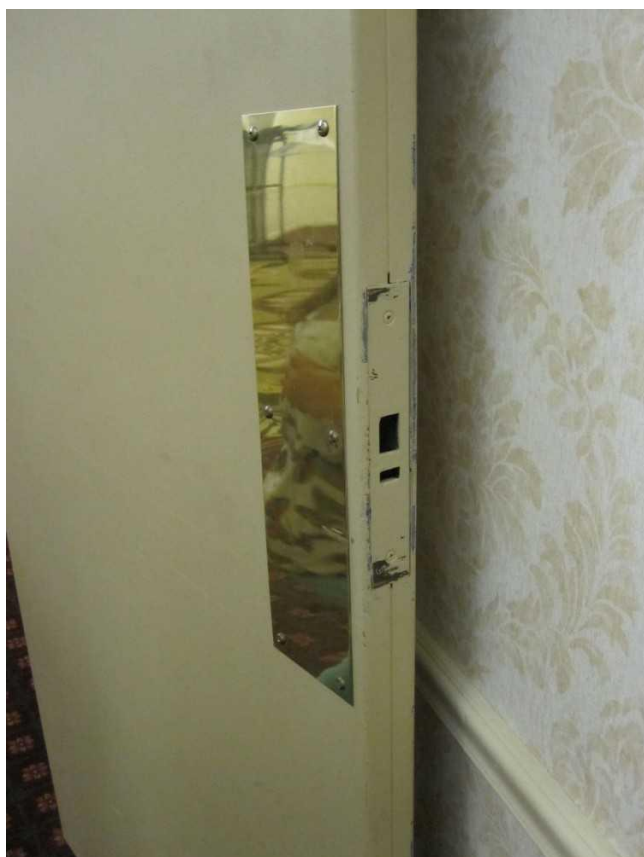
[Photo 3](#)

<p><a href="#">(Photo 4)</a></p>
Latch engages without excessive movement when shut.	No <i>Lock mechanism incomplete, new lock required.</i>	* Arrange for installation of a new latch. <b>Urgent</b>

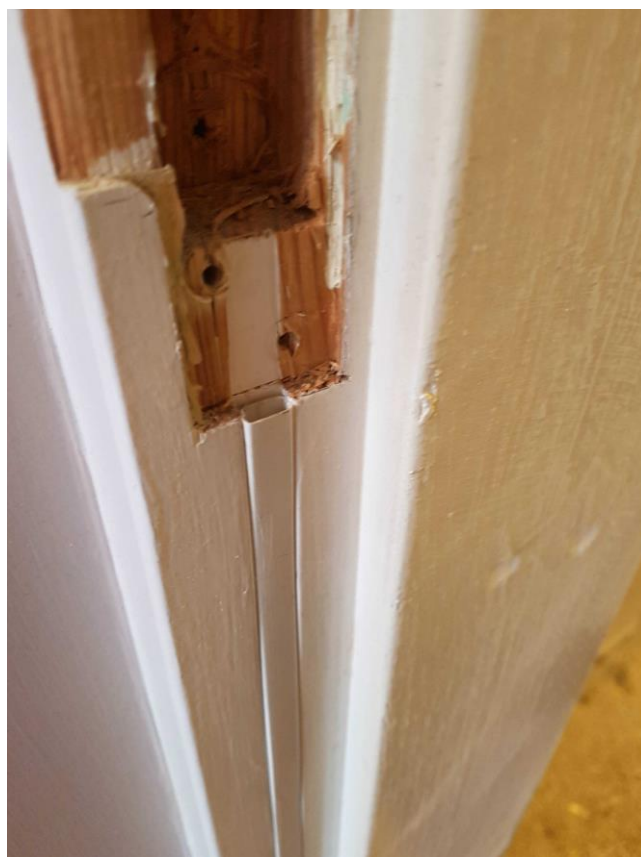
[Photo 4](#)

<p><a href="#">(Photo 5)</a></p>
Fitted all round & in (GC).	No	* Arrange for installation of intumescent seals. <b>Urgent</b>

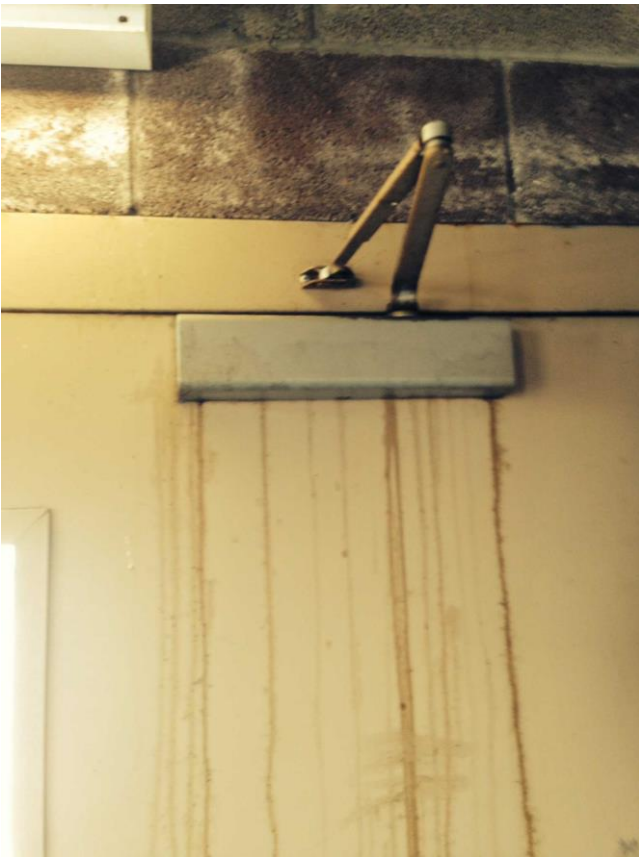
[Photo 5](#)

Fire-rated (CE Marked) hinges & all screws present.	Yes	No action required	No photo taken
Closers appear in (GC) without oil leakage.	No	* Arrange for installation of a door closer that is rated to BS1154 power level 3. <b>Urgent</b>
